## URGENT MEDICAL DEVICE CORRECTION

### CentriMag™ Acute Circulatory Support System Motor Model: 102956 *Compatible with CentriMag™ Pump and PediMag™ Pump*

September 5, 2018

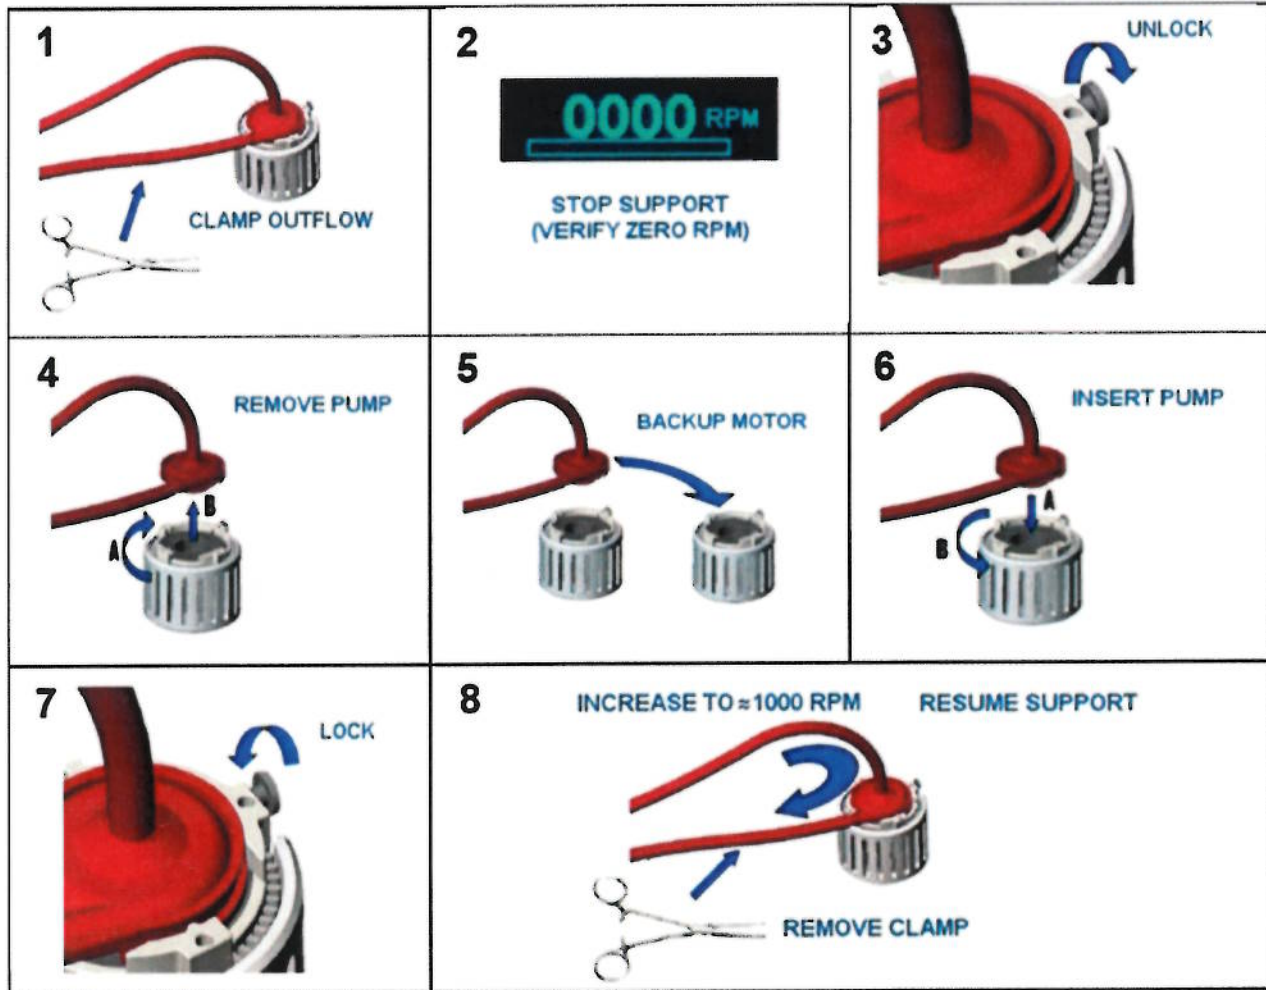
- Graphic regarding cable handling in the relevant CentriMag Circulatory Support System Operating Manual demonstrating the proper steps from transitioning a pump between the primary and backup systems.

- A full backup system must be in the immediate vicinity of every patient supported by the CentriMag System.
- Exchange the pump to the backup system as described in the CentriMag System Operating Manual and in Appendix 2. Improperly exchanging only the motor to a backup console could cause damage or harm.

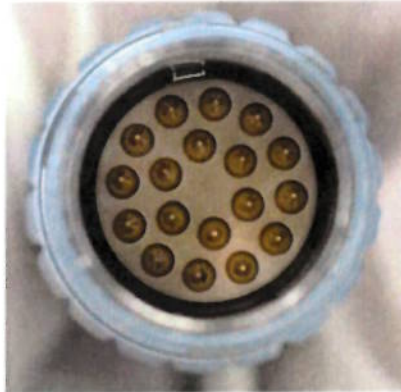
**Figure 2: Motor Connector Pin View**

- Visual inspection regarding inspection for motor cable damage from the CentriMag Circulatory Support System Operating Manual and supplemental pages (for 1<sup>st</sup> Generation Consoles)
1. Visually inspect the CentriMag Motor connector for bent or broken pins. Check for burn marks or melted plastic.

Note: If there are any issues while connecting the CentriMag Motor to the CentriMag Console, inspect the Motor port on the rear of the Console for damage, particularly for any broken pins that may be lodged inside.

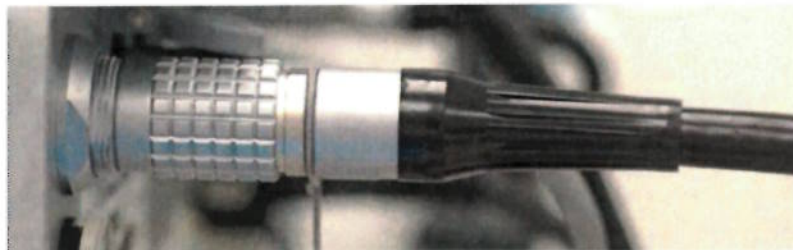
**Figure 3: Cable Bend Relief at the Console Connector**

2. Visually inspect the entire length of the CentriMag Motor cable, including both bend reliefs (see Figures 3 and 4), for any damage such as separations of the bend reliefs, deformations, kinks, or cuts. These types of damage indicate wear and tear or previous rough handling of the cable, which has the potential to result in internal wire damage. Cable thickness and shape should be uniform throughout the length of the cable.

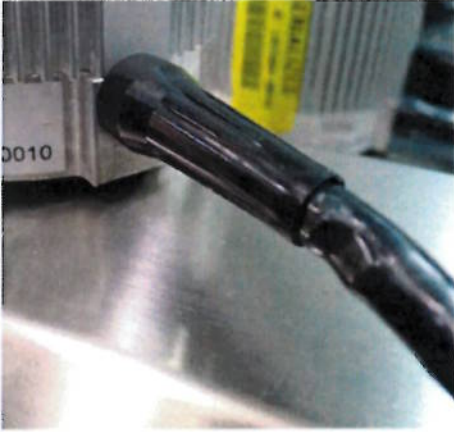
Our analysis of devices associated with the motor stop field complaints showed that the motor stop can be attributed to a break of a wire or short circuit between wires within the electrical cable where the cable exits the motor cable bend protection. This damage may be avoided by ensuring proper handling, such as avoiding tight bending of the cable, or winding the cable around the motor during storage during the life of the motor.

**Figure 5: Cable Damage at the Motor Bend Relief**

- Inspection of the CentriMag Motor, including the cable, for damage should be conducted prior to use. Do not use if damaged. If the cable is damaged and not visible as part of the inspection, the console will alarm during the procedure. Further detail about the visual inspection can be found in Appendix 3.

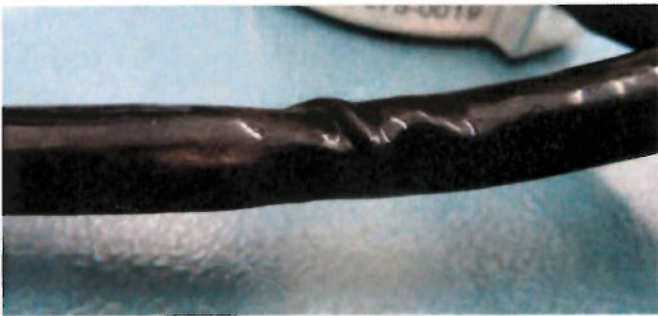
**Figure 7: Damaged Motor Cable**

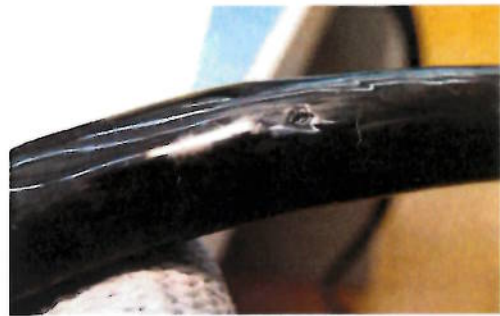
**Figure 8: Damaged Motor Cable**
